Article

Consequences of an assembly error in the largest photovoltaic facility in the world

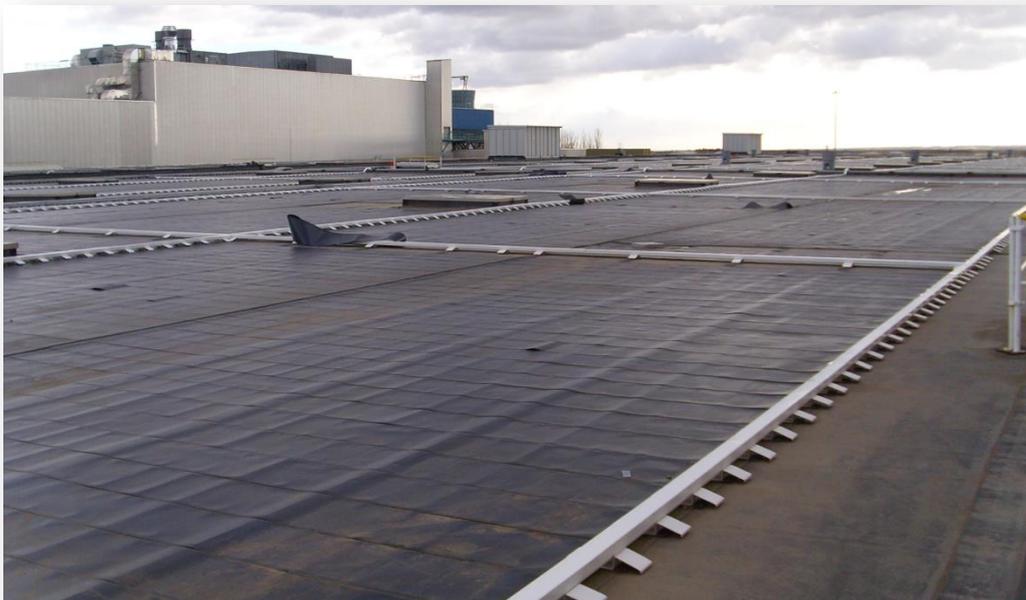
Plan view of the photovoltaic facility on one of the roofs

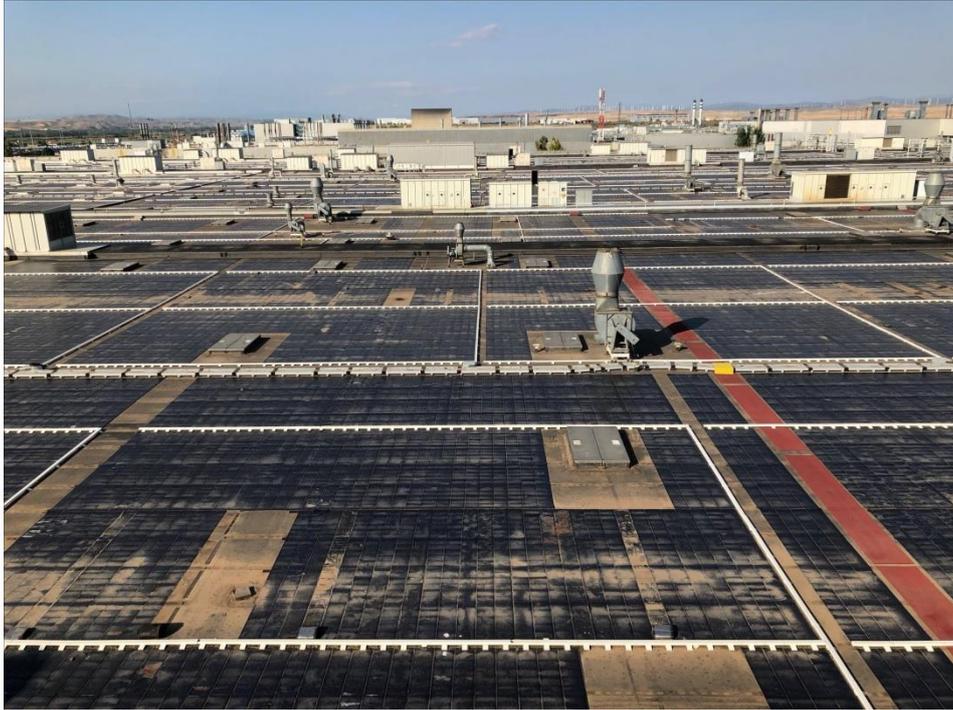
View of the photovoltaic facility on one of the factory roofs

The Velcro® sheet adhered to the panel was joined with Velcro® strips distributed on the roof. The size of the strips was calculated in accordance with the CTE (Technical Building Code) to withstand the action of environmental agents (snow load and wind load).

The Velcro® was attached to the panels and also to the roof by applying adhesive onsite during assembly after first applying a primer, whose function was to clean the adhesion surface and strengthen the adhesive properties.

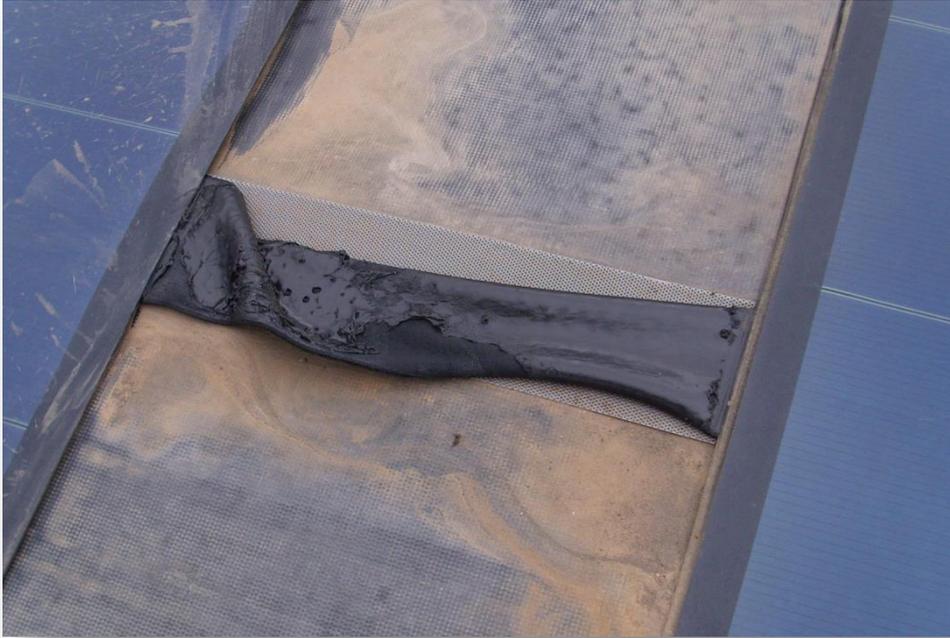
Also worth noting is that most of the panels had been pulled away where the Velcro® is attached to the panel, in other words, the wind's dynamic pressure had exceeded the adhesive's adhesion capacity.

Observe the condition of the Velcro® after a panel came away

To determine the failure mechanism of the panel anchoring in the photovoltaic facility, [RTS INTERNATIONAL LOSS ADJUSTERS](#) requested a study in an accredited laboratory. It was concluded that the panel anchoring failed due to an assembly fault during installation, namely a lack of primer on the panel base involved in the attachment.

This meant the adhesive used on the surface of the panel base to attach the panels to the roof did not adhere properly and, consequently, the attachments lacked resistant properties.

The investigation conclusions were shared with the insured and policy broker, thus enabling a claim to be made against the main contractor of the work as the facility was under warranty. Since the contractor paid the cost of rectifying the error, all the intervening parties—insurance company, broker and insured—were satisfied with the involvement of RTS International Loss Adjusters.
