OPINION PIECE

Ricardo Vasquez, Director of the RTS International Loss Adjusters office in Peru

El Niño Phenomenon: Damages and Prevention

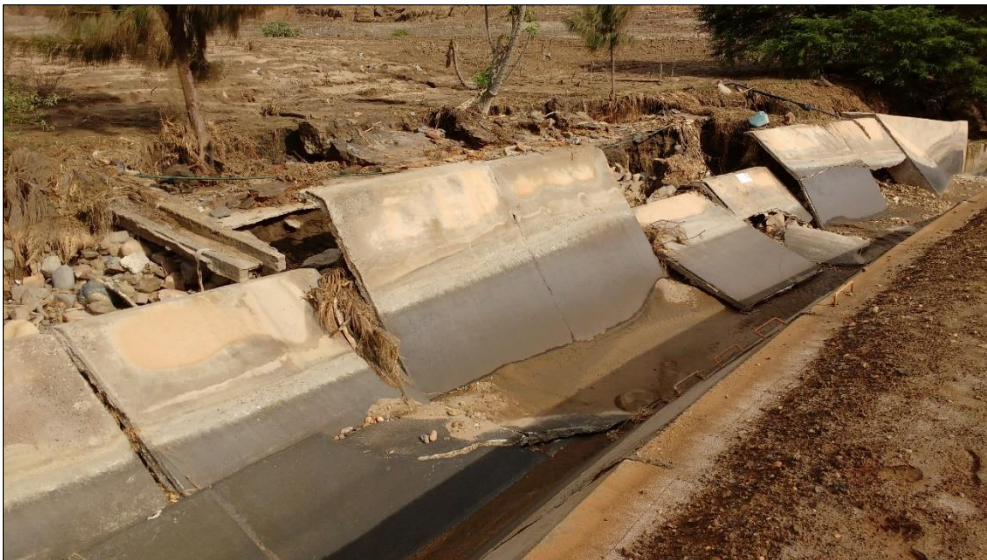
Irrigation channels sustain structural damage, since concrete slabs are destroyed and in specific cases the entire civil structure collapses as it is undermined by mudslides. Hydraulic structures that overflow due to rainfall prevent the normal flow of water needed to irrigate crops in rural areas, which affects agriculture in the north of the country.

We have also observed that approximately 60% of irrigation channels in areas where this rainfall occurred were affected by these phenomena. The main losses were due to the collapse of these channels because they were inundated by mud and earth. Rocks were dragged by the surface run-off of watercourses that had been inactive for several years, and in some areas the channels were even totally buried for several kilometres.

Other damage that we frequently came across was the fracture of unreinforced concrete slabs forming the channel. This was due to the foundation soil of the channel becoming saturated, which then pressed against these slabs and destroyed them.

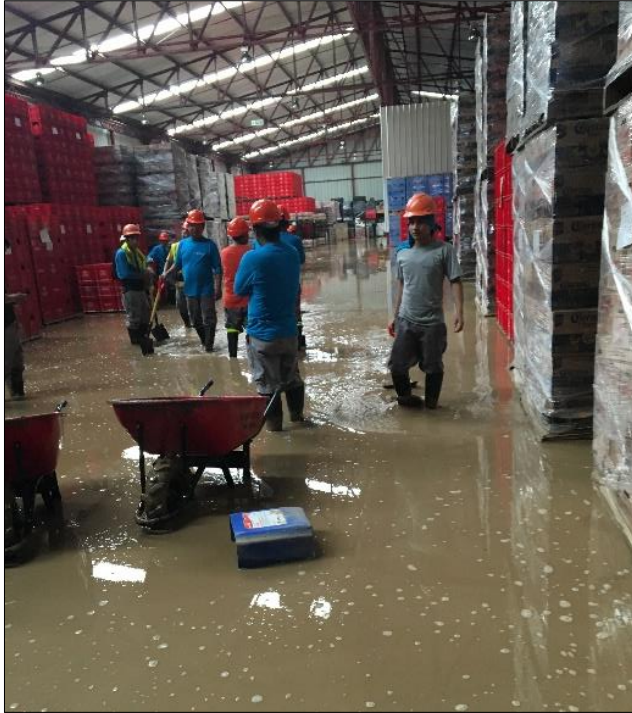
The property losses mainly arose due to flooding caused by the rain and surface run-off entering premises, which damaged machinery, equipment, electrical systems, and so on.

The business interruption was caused by the delay in reconstructing the plant and starting it up again. In other words, the time it took to clean and repair the electrical and electronic parts of the equipment forming the production lines.
