Article by Francisco Galadi (Technical Industrial Engineer, Traffic accident reconstruction investigator and external collaborator of RTS)

'Newton and Reyes accident'

After the tragic accident in which the football player José Antonio Reyes lost his life in June 2019, Francisco Galadí went to investigate the scene. The expert investigator and specialist in traffic collision reconstructions, has questioned some of the theories surrounding the accident and has pointed to a tyre blowout as a possible cause.

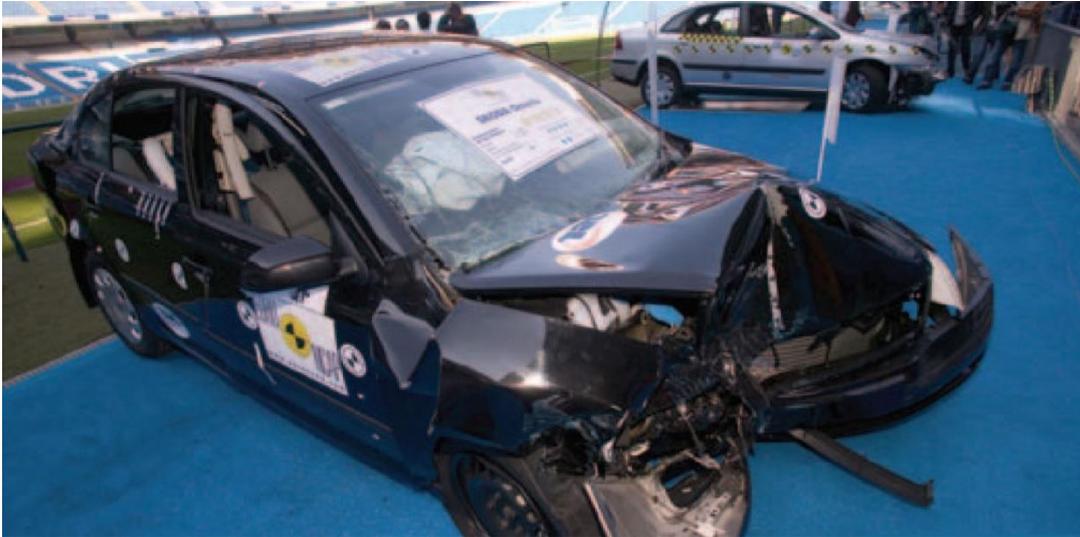
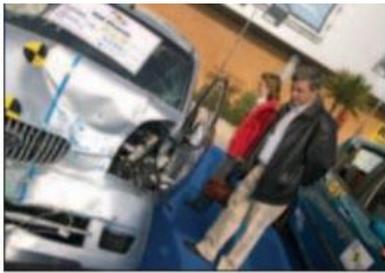
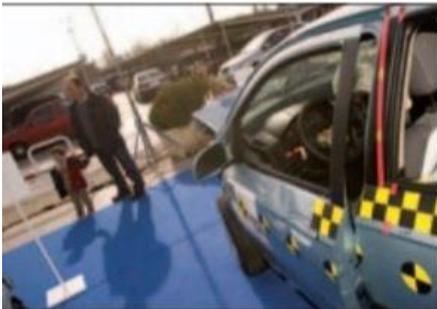
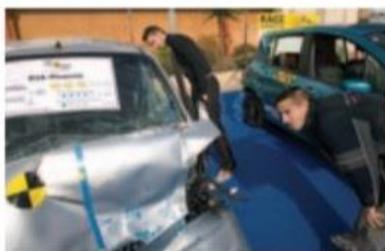
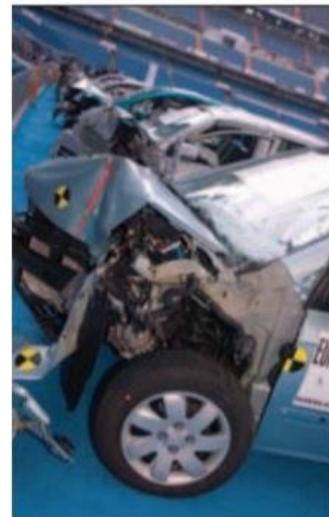
For this same reason, we should not let ourselves be misled in thinking that the deformations caused to a vehicle can be indicative of the speed at which it was travelling at the time of the collision, without using technical means to verify that speed. For a better understanding, we suggest a careful examination of the photographs attached below. They were taken during a demonstration set up by the DGT (Spanish Directorate General of Traffic),

at the Santiago Bernabéu Stadium, showing vehicles that had collided against a rigid body, at a speed of only 50 km/h! Note the practically destroyed condition of the vehicles and remember that they were travelling at a speed of no more than 50 km/h.

Thus according to Newton, if a vehicle collides against a wall at a speed of 50 km/h, the effect on the bodywork is similar to that of an impact at 100 km/h, because the wall does not give way and remains rigid and thus the two opposed forces that are generated dissipate the deformation energy through the vehicle's bodywork only.
